Engineering &  
Maintenance

**APU failure after more than 7 days parking of aircraft**

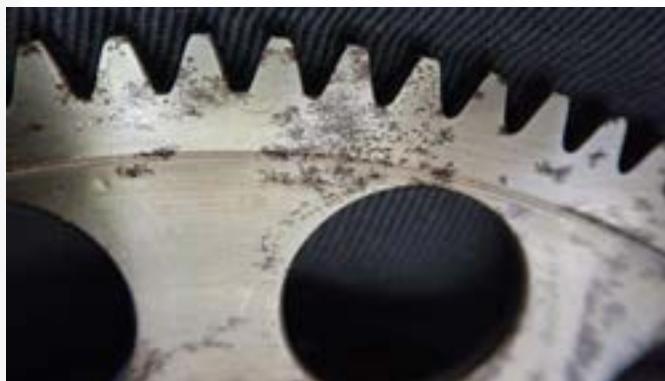
"After thorough inspection, we found corrosion on the gears. This usually indicates a humidity issue, and consequently inadequate preservation and storage measures. We consulted Honeywell, the OEM of this particular APU.

*Seized compound idler gear*

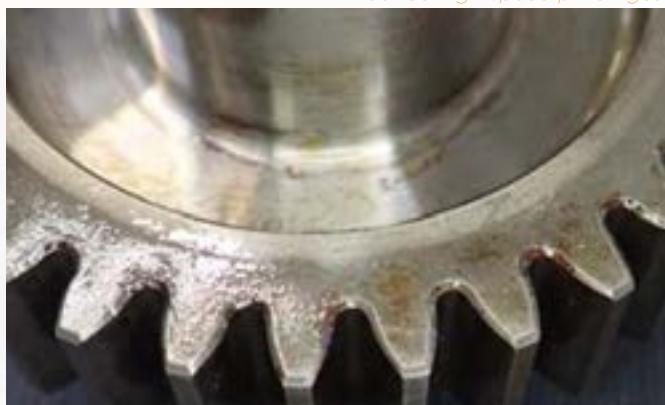
*Seized high speed pinion gear*
