Engineering &  
Maintenance

**APU failure after more than 7 days parking of aircraft**

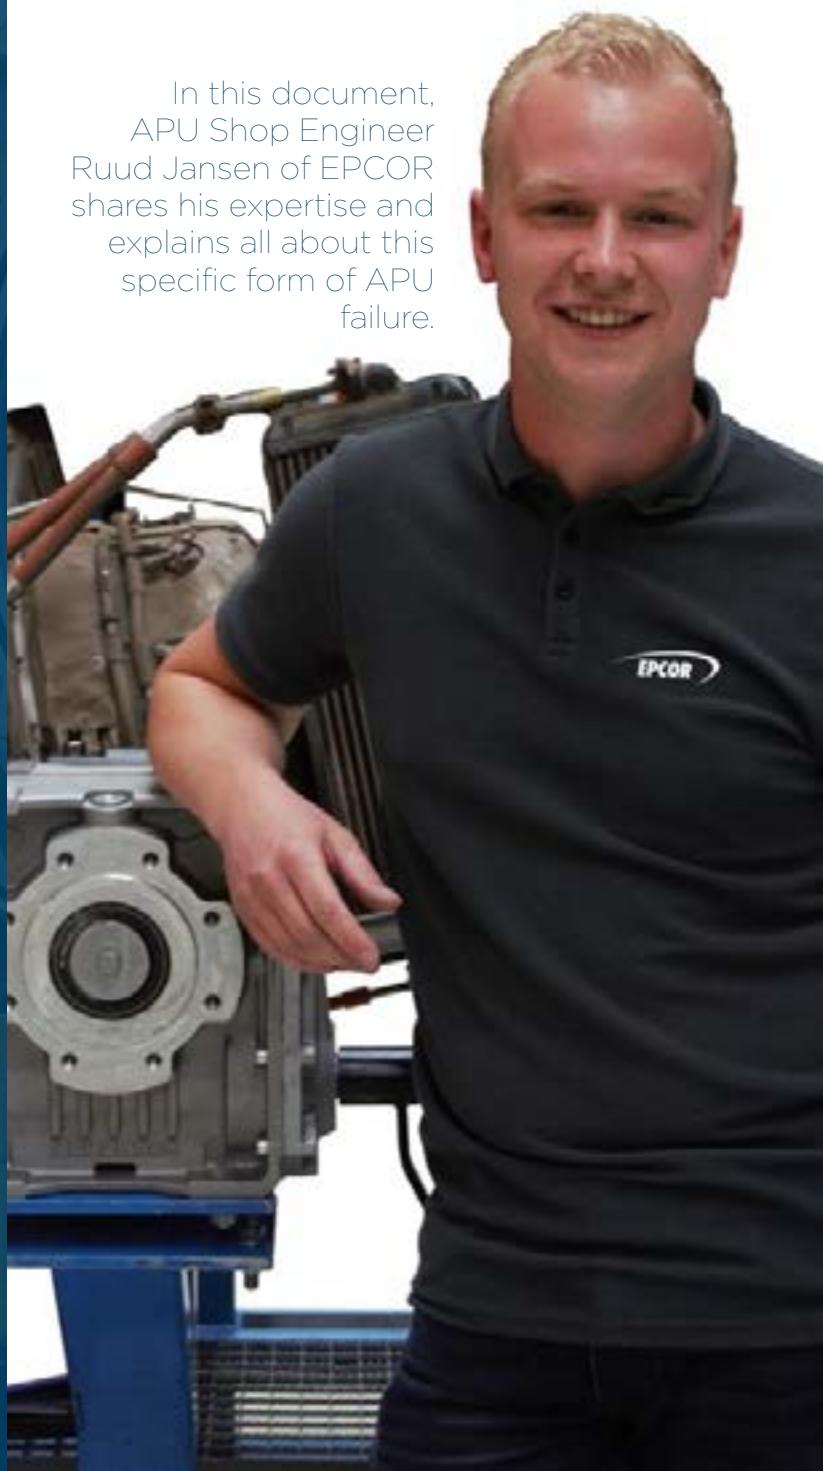
"During incoming inspection of an APU, we found the rotating assembly was completely seized. The load compressor, which is the middle section of the APU, got stuck with its knife edges in the abradable seal surrounding it."

"After thorough inspection, we found corrosion on the gears. This usually indicates a humidity issue, and consequently inadequate preservation and storage measures. We consulted Honeywell, the OEM of this particular APU.

They confirmed our presumption that a lack of preservation measures may result in corrosion and the swelling of any abradable coating. Once the abradable seal is swollen, the knife edges of the load compressor have too little room to rotate freely. They run into the abradable seal and cause the rotating assembly seizure and the APU failure."

"Due to humidity, the abradable seal of the load compressor expands. The knife edges will no longer rotate freely beside the abradable seal, but run right into it. This immediate damage is local. No other parts of the APU are affected.
